CASE STUDY

Client: **trac**
 Details: **Stromeferry**
 Project: **Stromeferry Bypass**

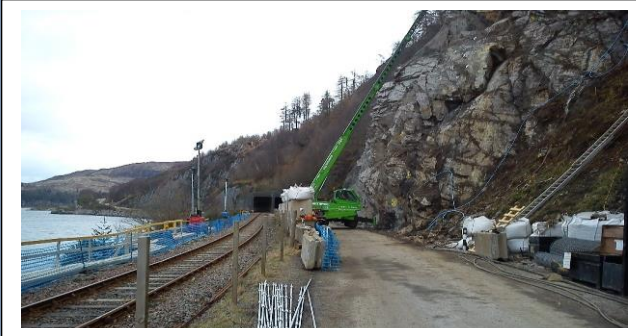
Prior to works

A rockfall in 2011 resulted in the closure of the Stromeferry bypass for several months, with motorists facing a 130-mile diversion. In 2018 a report for the rock face condition was undertaken and identified as very high risk. A set of complex engineering works on the rail infrastructure was required to facilitate these works. Something had to be done... in came Premier Rail!

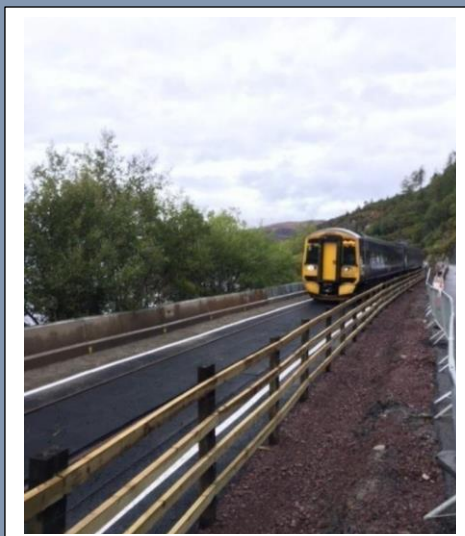
Finished Project

Network Rail comprised a scheme with the installation of a roadway that could be shared by both trains and vehicles while remedial works to the rock face were undertaken. Premier Rail secured the lead role, installing of over 200 metres of the Rosehill Base plated Crossing System on the rail infrastructure. Due to the curvature of the route, approximately 40% of the panels required a cut to fit installation on site, to accommodate the joints in the track and the spacing of the bullhead chairs.
